CHAPTER 8

CONCLUSIONS

Figure 27

Illustrations from the Ferracute Machine Company catalogue

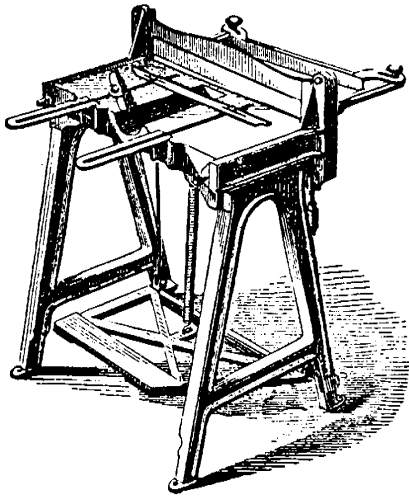
20 inch Squaring Shears.

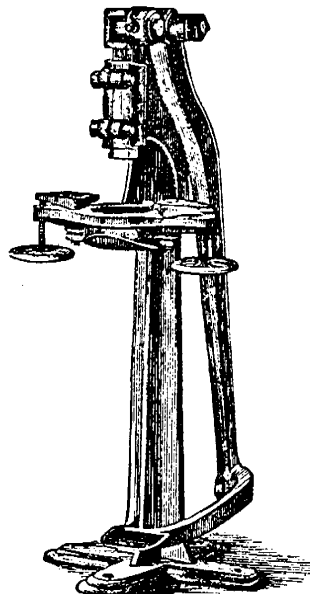
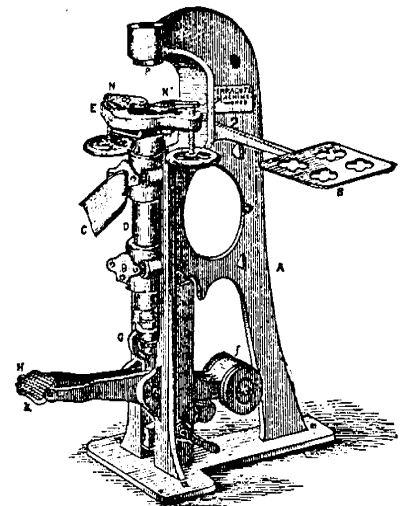
Pendulum Foot Press.

Pendulum Foot Press. Bottom Slide Foot Press.
